CENTRAL INTELLIGENCE AGENCY

INFORMATION REPORT

SUBJECT Pilsen (Bory) Military Airfield

Annex I Pilsen Military Airfield

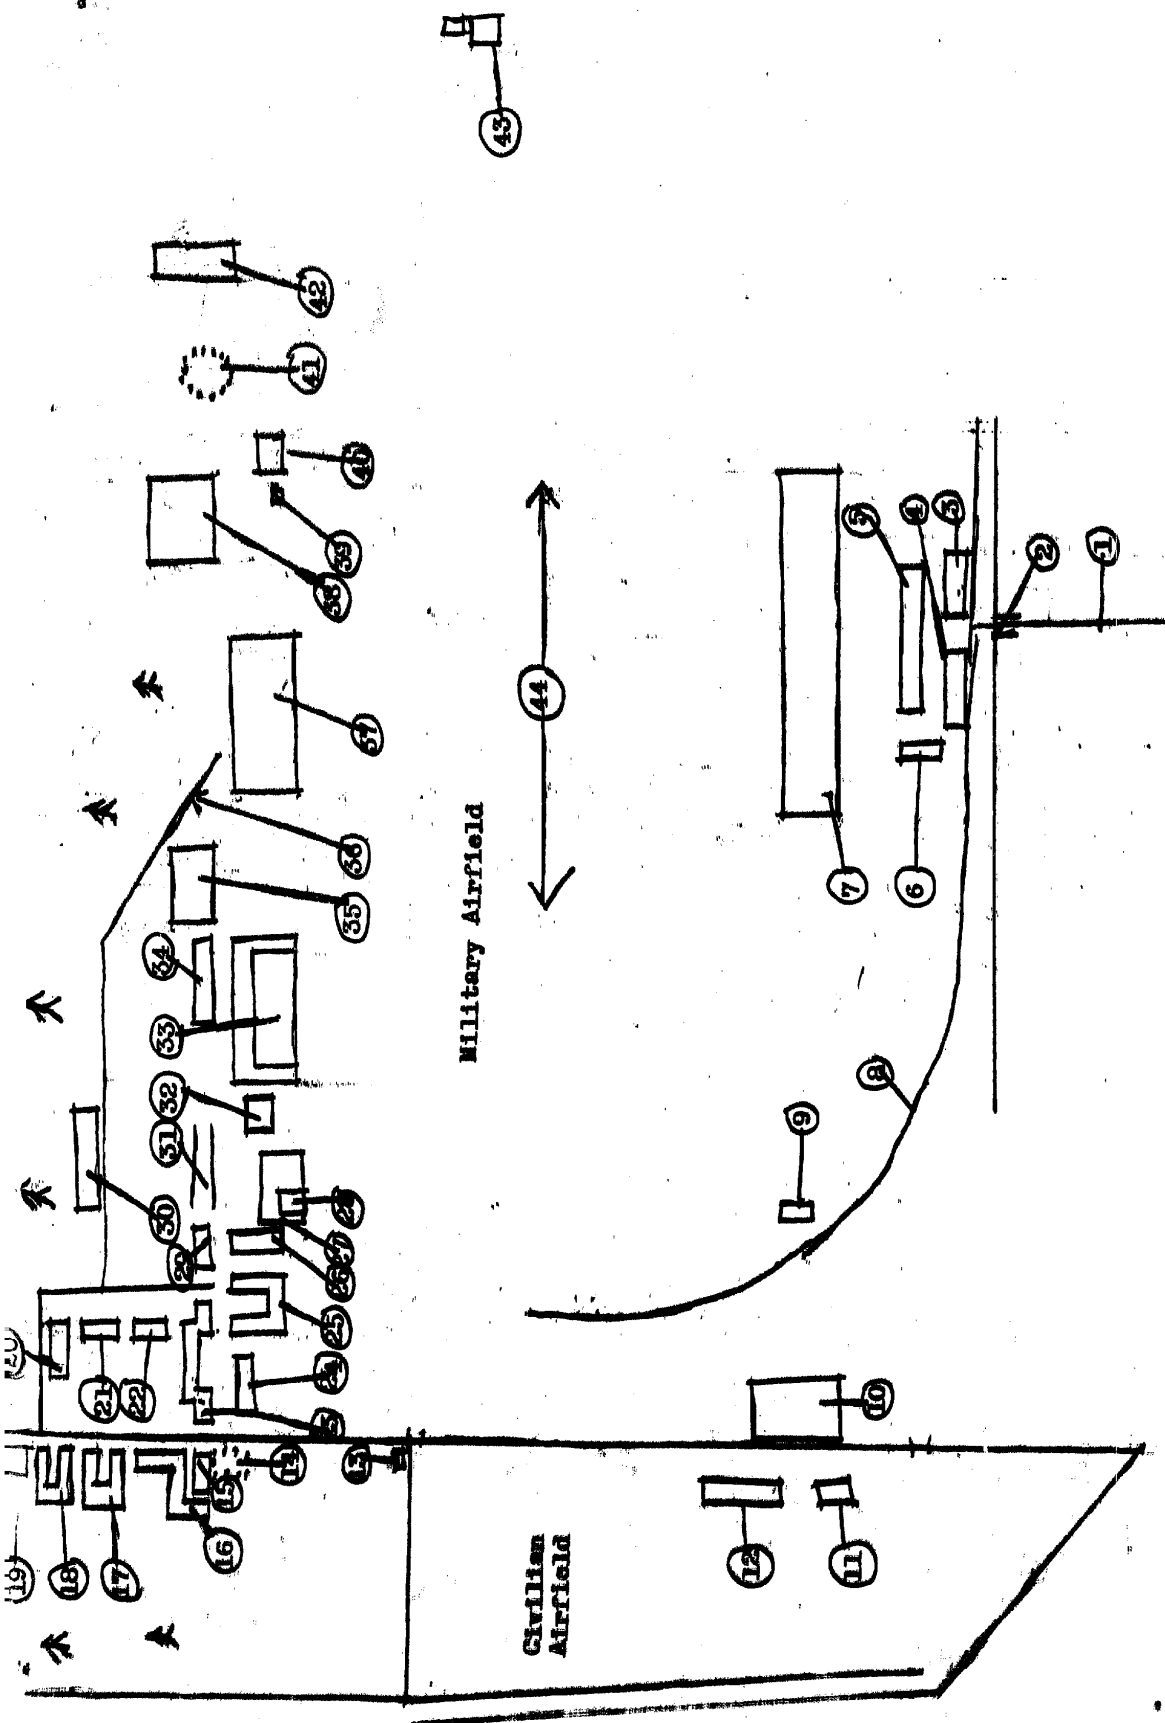
See Annex I, this report, [redacted] sketch of the military airfield, Pilsen (Bory)

1. ROAD, four m. wide, packed surface, led from Pilsen to the airfield.
2. ENTRANCE, guarded 24 hours a day by one military guard dressed in dark blue uniform, armed with submachine gun.
3. BILLETS, brick, three-story, gable roof, dimensions unknown. Troops were billeted there.
4. MAIN ADMINISTRATION BUILDING, brick, three-story. control tower on top of roof. [redacted]
5. GARAGES, brick. Passenger cars and trucks were parked there.
6. HOUSE, brick, single-story. Officer and his family lived there.

7. RUNWAY, made of concrete slabs (5 x 5 m.), length 260 m., width not recalled, natural drainage along sides, well kept. [redacted] runway was rarely used since most of the aircraft landed and took off from grassy area /Pt. 44/. 25X1 25X1

8. ROAD, 4.5 m. wide, concrete.
9. GONIO STATION, no information.
10. HANGAR, description and dimensions unknown; hangar belonged to a civilian airline (name unknown).

11. TWO WOODEN BARRACKS, also part of the civilian part of the airfield.
12. BUILDING, single-story, wooden, purpose unknown.
13. GUARD STATION, with one military guard on duty 24 hours a day.

14. BUILDING UNDER CONSTRUCTION, brick, dimensions unknown. [redacted] part of the building will be used as a stockade and part as bachelor quarters or billets for career airmen. 25X1 25X1

15. OFFICERS' MESS, wooden, single-story.
16. BILLETS for career airmen, wooden, single-story.
17. BARRACK, wooden, "U" shape, in very poor condition, contained some offices.

18. BILLETS, wooden, "U" shape.
19. MOVIE THEATER, wooden, canteen was also located there.
20. BILLETS, brick, single-story, troops stayed there.
21. BILLETS, brick.

22. BILLETS, brick.
23. BILLETS for officers, brick, single-story.
24. BARRACK, wooden, single-story. Guards used to assemble there.
25. BILLETS and OFFICE BUILDING, wooden.

26. BARRACK, wooden. Sometimes used as officers' billets.
27. BUILDING, brick, two-story, contained offices and control tower on top of roof. /See Pt. 28/.

28. CONTROL TOWER, roof and sides were made of glass. [redacted] two transmitters of Czechoslovak origin. Frequency and type unknown; searchlight was located on top of the tower. On top of the roof next to the control tower was a 7.92-mm. calibre machine gun. No further information. 25X1

29. FIRE STATION, wooden [redacted] 25X1 25X1
30. MESS HALL for troops, wooden.

31. STORAGE SHEDS, wooden, single-story. Aircraft parts of unknown type and quantity were stored there.
32. FUEL STATION.
33. HANGAR, brick, type of roof not recalled, dimensions unknown.

34. WORKSHOPS, wooden. Fuel tanks were inspected there for possible leakage and repaired if necessary.
35. HANGAR, wooden, barrel shell roof. No further information.

36. ROAD, four m. wide, packed top.
37. HANGAR, brick. No further information.
38. HANGAR, wooden; two Piper Cubs, two Arados, one Me-109 could be accommodated there.

39. UNDERGROUND FUEL STORAGE; LPH-87 (octane) fuel was stored there; capacity of storage unknown. [] fuel trucks being filled there. 25X1
40. BUILDING, brick, single-story. Radio station was located there. Transmitters LR-16 and LR-22 were used for announcing interception of foreign aircraft. No further information.

41. AREA [] several excavations. [] 25X1
42. BORE SIGHTING RANGE, about 100 m. long, 25 m. wide, 1 m. deep in ground, dirt sides and floor, with concrete space where aircraft was parked when weapons were tested. Earth fill was used as a target. No further information.

43. RADAR STATION [] 25X1
three [] in uniform walk toward the radar station, one officer, one PFC, and one corporal. They were not accompanied by Czechoslovak personnel.

44. GRASSY AREA used for landing and take-off. Area was about 1,000 m. long and 500 m. wide.
